FORMER TRW MICROWAVE SITE

Current Site Status and Upcoming Field Work

August 12, 2022

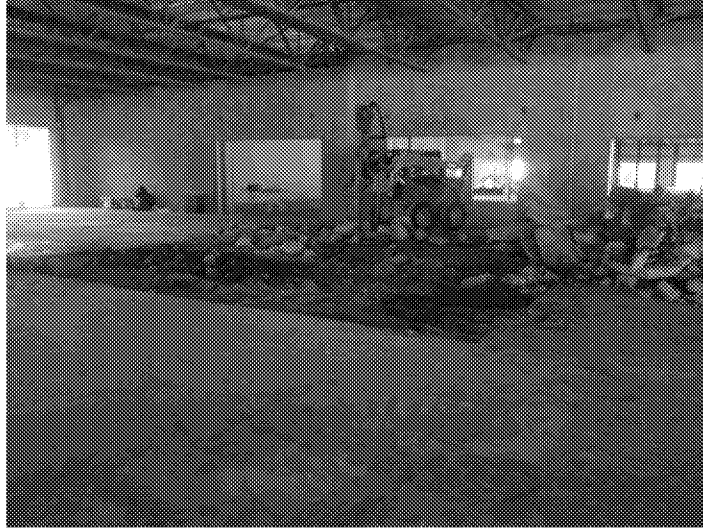
Breaking up
concrete for
expanded
excavation
activities

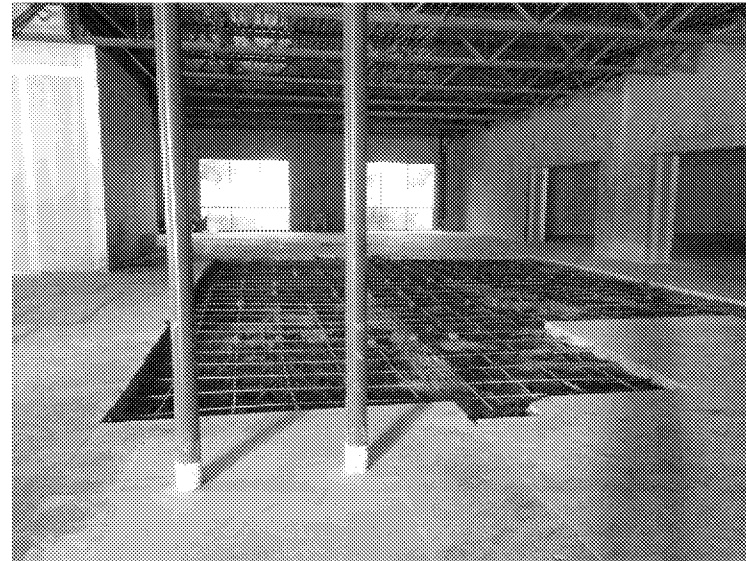
Extent of the
excavation area
(fitted with rebar
after excavation
activities
complete) looking
north with vent
risers for the
passive sub-slab
vapor collection
system in the
foreground

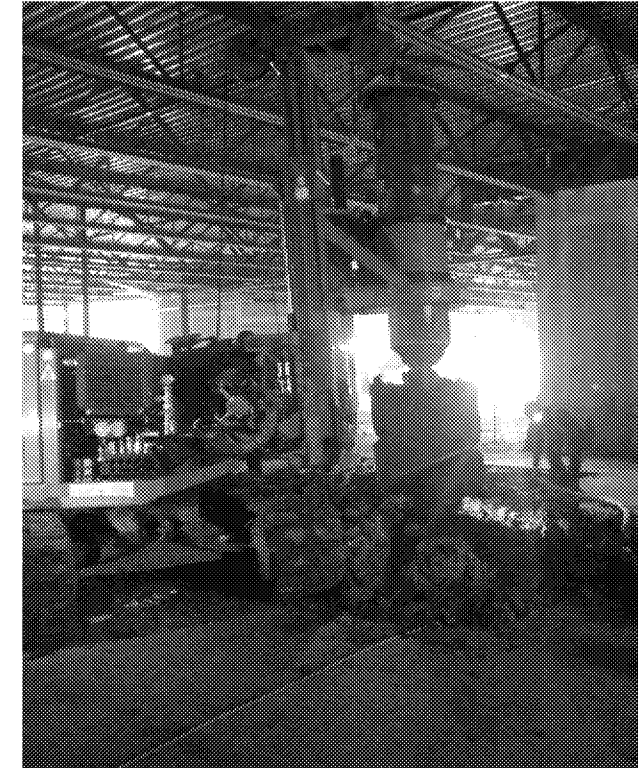
Large diameter auger
